## A Solid Solution

**Eco-Infrastructure**

Jan 19, 2018

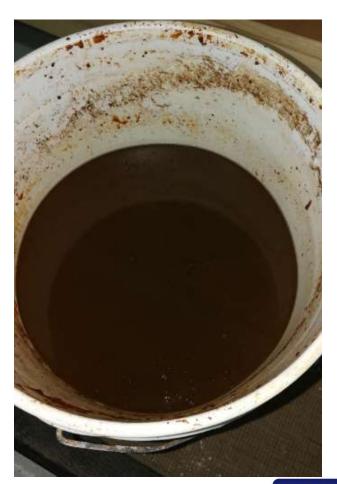
- 9lb/gal
- High salt content:~50,000ppm
- Noticeable hydrocarbon content
- High in iron, as seen from the reddish color
